**PRESENTATION BY [REDACTED] CLARIFYING THE
FEBRUARY 15, 2001 REPORT BY EXPONENT, INC.
PRESENTED AT THE APRIL 27, 2001 MEETING WITH FEMA
IN COLUMBIA, SOUTH CAROLINA**

EXECUTIVE SUMMARY

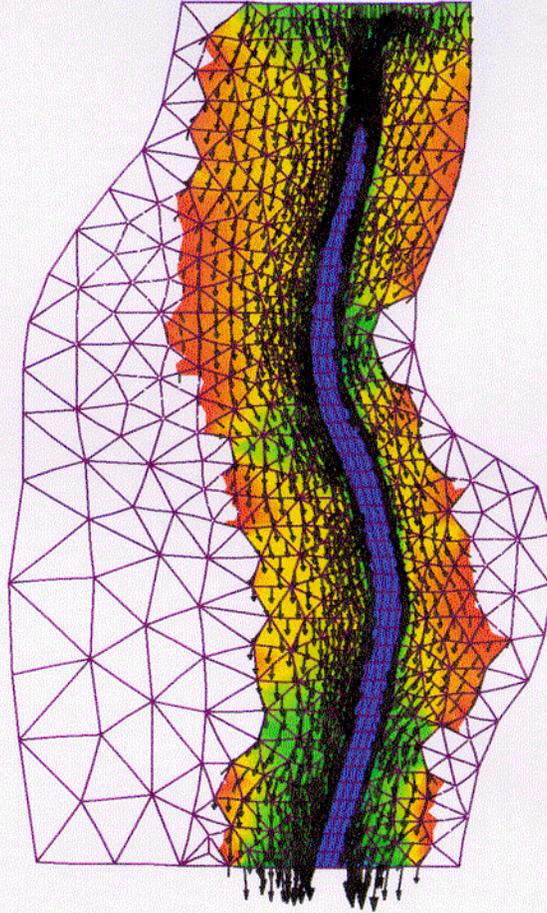
SLIDE 1

WHAT A FLOODWAY LOOKS LIKE IN A TWO-DIMENSIONAL MODEL

This is what a floodway looks like in a two-dimensional model. This is the river. This is the floodplain. Along this part of the floodplain the flow is unobstructed and the pattern, indicated by arrows, is parallel to the main river. In a floodway, the velocities are high. These white areas indicate low velocity and are not floodway. The most important characteristic of a floodway is that it eventually returns the water to the river.
