Observations of Floodway Definition for the  
Congaree River in Richland and Lexington  
Counties, SC

## Overview

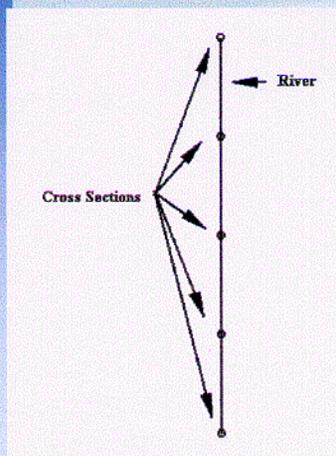
## 1D Models

- **Assumptions**

- Flow perpendicular to cross sections
- Flat water surface across cross section
- Linear variation between cross sections

- **Limitations**

- Non continuous solution
- User defined effective flow regions

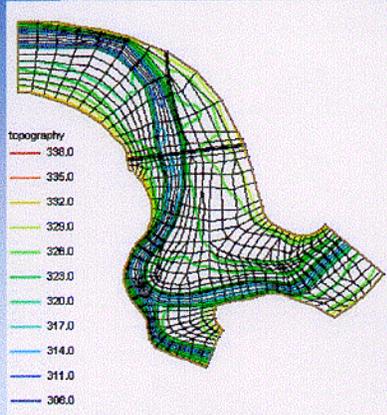
## 2D Models

- **Assumptions**
  - Negligible vertical component
  - Non stratified flow
  - All significant flow included in domain
- **Benefits**
  - Continuous solution
  - More flexible

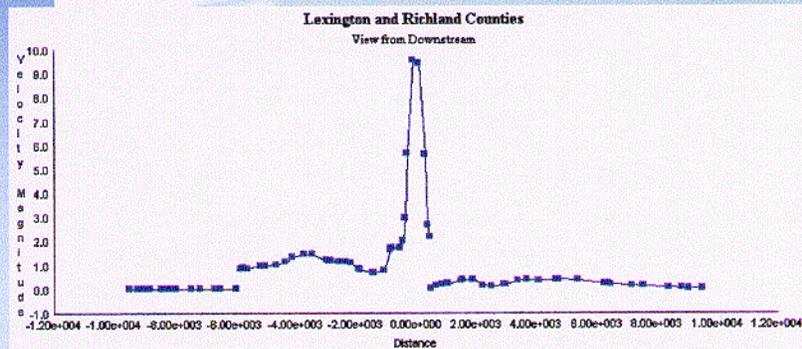
## Calibration of 1D to 2D?

- Impossible if 2D conditions exist
- Curve in 2D – Straight Line in 1D
